2018 European Manufacturing Symposium

Unpleasant electrical shock due to static electricity

Examples:

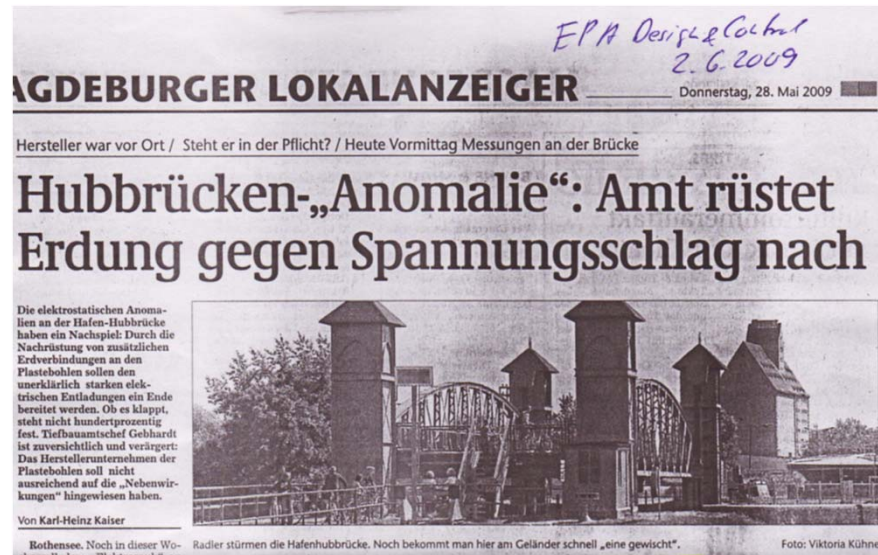
The walkway of a historical bridge was refurbished with plastic timbers instead of the original oak timber.

At the ribbon cut party the participants received unpleasant electrical shocks.

Metal strips between the plastic timbers to discharge pedestrians and to limit the accumulation of static.

At the stairs, the plastic timbers have been replaced by grounded metal grids.

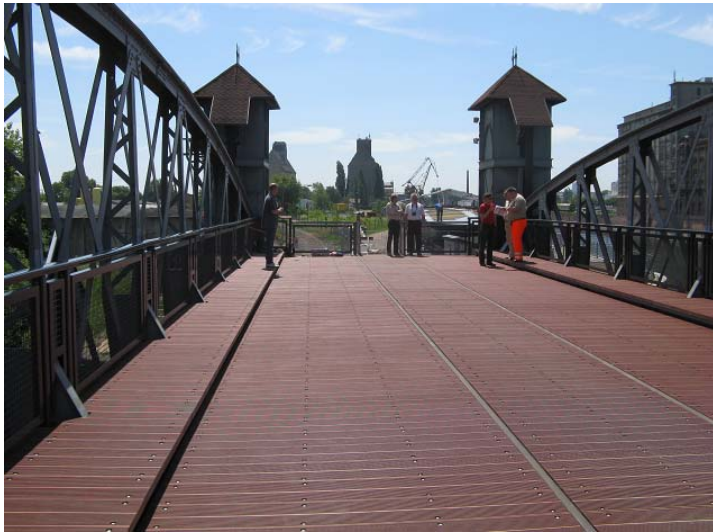
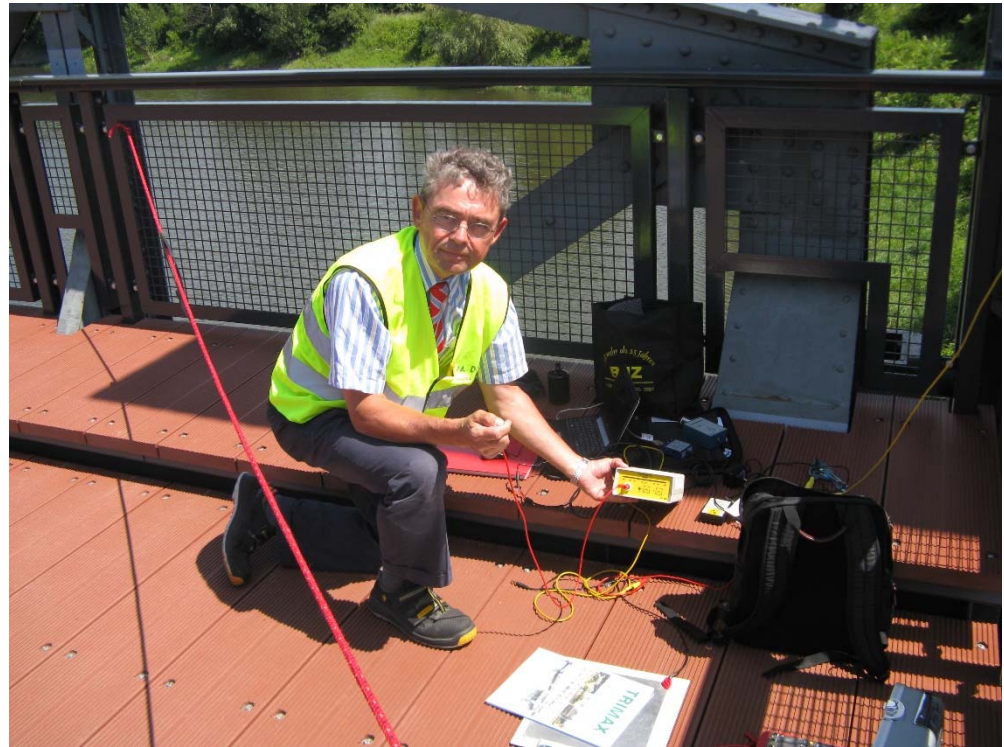
ESD measurement on site

I was called to analyze the situation.

Voltage on a person with ESD shoes $U_s > 15.000 \text{ V}$

Interesting: With Street shoes $U_s \approx 10.000 \text{ V}$

Sensing strong ESD at the rails, also sensing ESD through the soles of my shoes.

capacitance 200 pF – 18 kV = **33 mJ**

10 % of what is considered a direct hazard to health 350 mJ. Certainly unpleasant !!

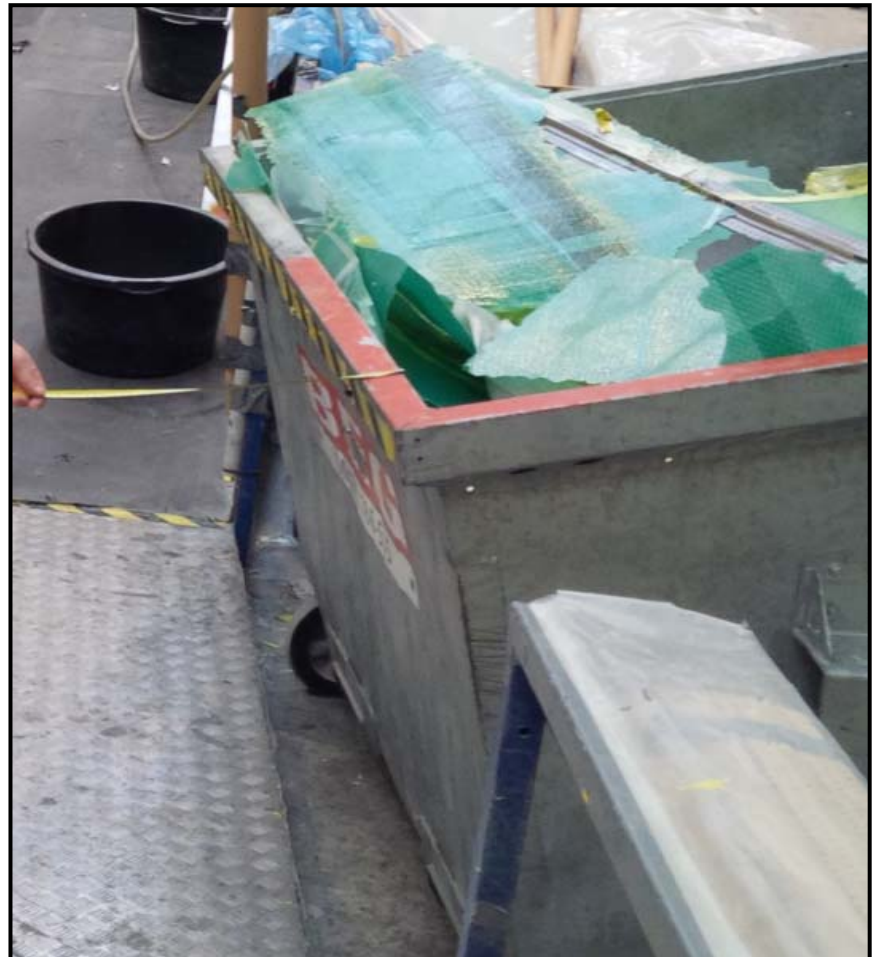
- In a plant large amounts of plastic waste was collected in metal containers.
- To improve the material flow, the metal container was placed on a trolley.
- The container app. 10 m³, was on a trolley with plastic wheels, unfortunately fully insulated.
- Workers reported severe ESD shocks when they came close to the container.

I received a *nice ESD* over app. 20 cm!

All Charge on the plastic waste is also on the surface of the container!

Conductive containers must be grounded during loading and unloading.

Visual inspection on site identified installed grounding points and cables, but not used.

Solution: Training and instructions must be provided Ref. TRGS 727 Pt. 8.6

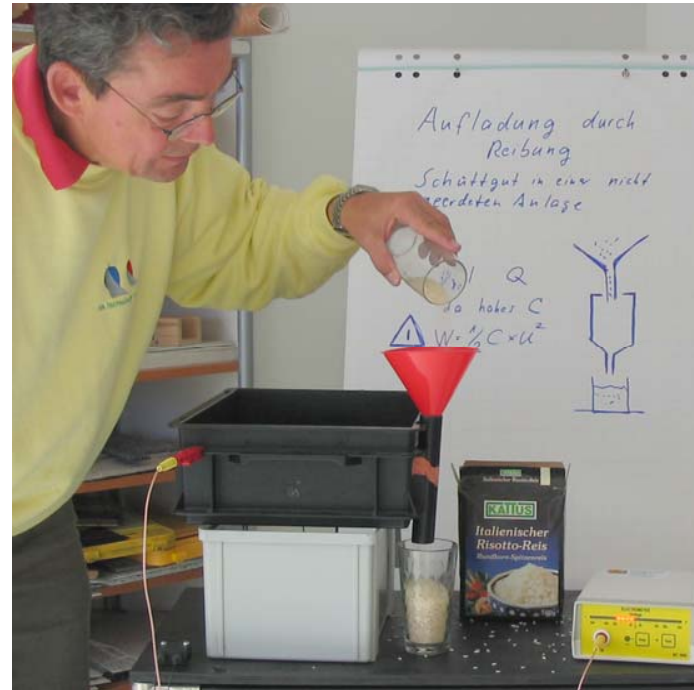
Demonstration

Dry rice, charged by friction, can charge the conductive pipe and charge up a conductive tote box.

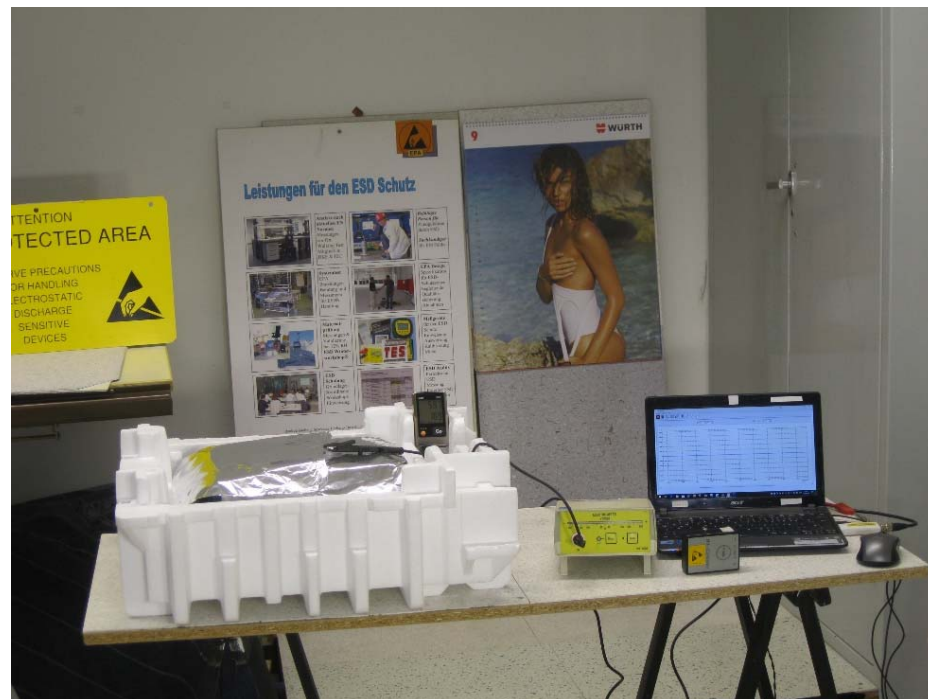
Table

Items in the box
wrapped in metal foil.
The voltage of the
wrap was recorded.
